**DEFENSE NUCLEAR FACILITIES  
SAFETY BOARD**

## Staff Issue Report

**SUBJECT:** Waste Treatment and Immobilization Plant Quality Assurance Review

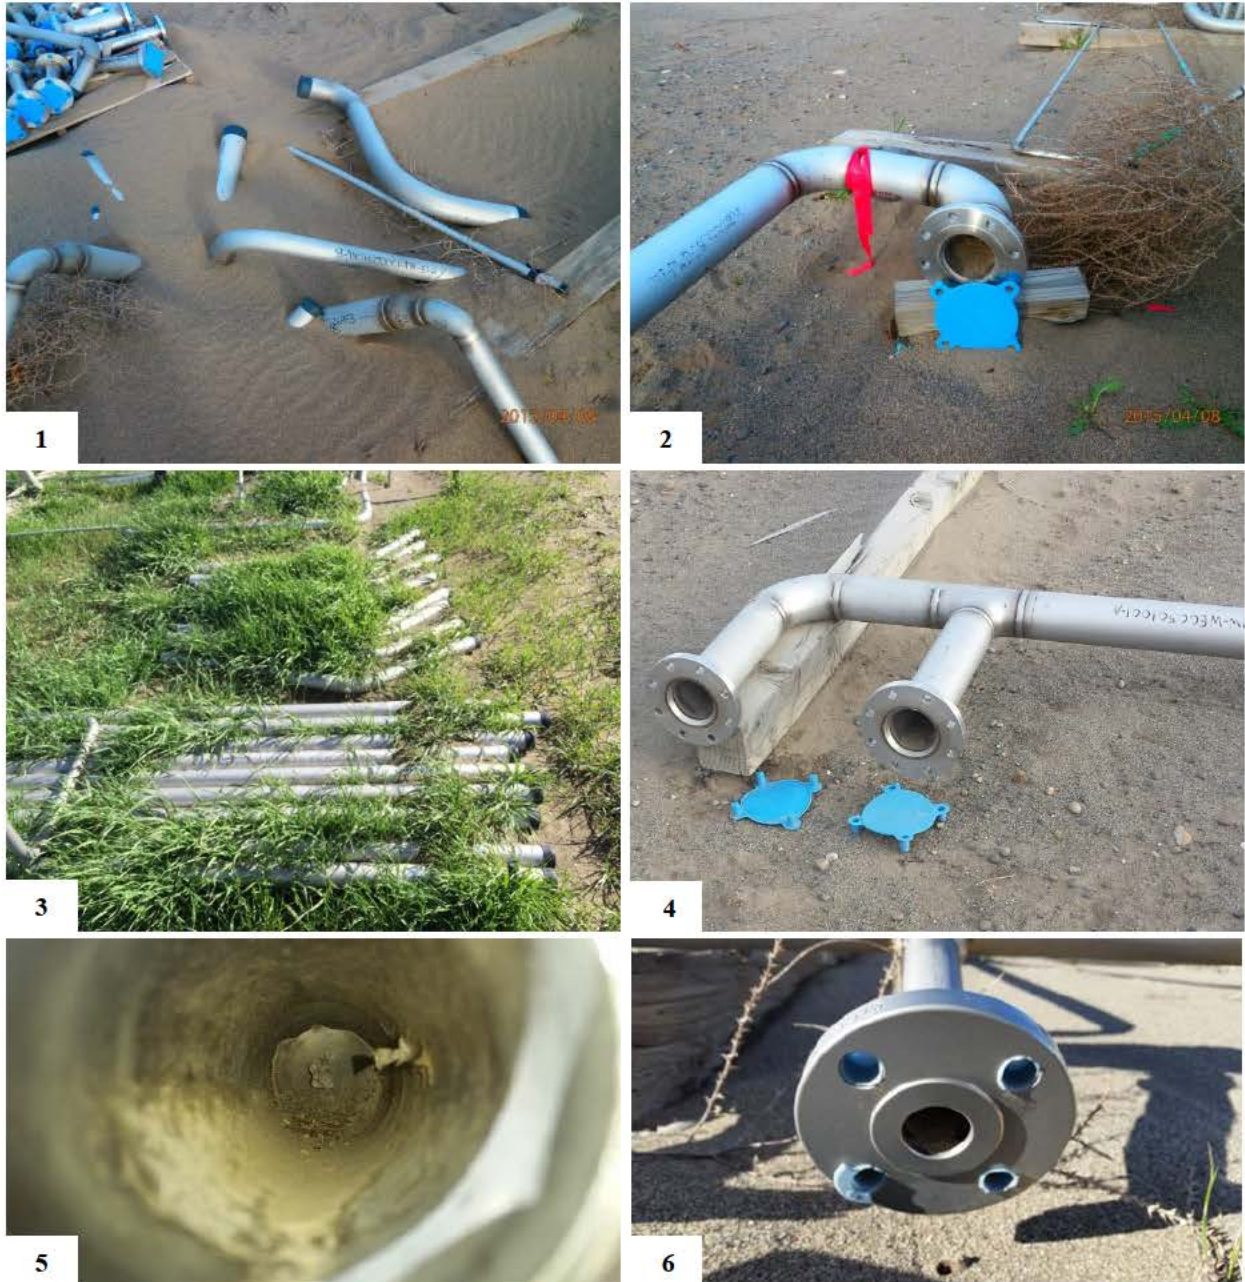
*Deficiency 1, SSC Storage at the MHF Laydown Yard*—In April 2015, at the MHF Laydown Yard, the staff photographed a substantial number of pipe spools and other SSCs buried in the sand and surrounded by excessive vegetation. Some SSCs were missing required protective coverings on their openings, and as a result, some SSCs showed signs of animal intrusion, contained standing water, or had a buildup of sand inside. See Appendix 1, Figures A-1 to A-8, for example photographs. These storage conditions are contrary to the following requirements:

**Figures A-1 to A-6.** Staff review team photographs illustrating deficient storage conditions at the Material Handling Facility (MHF) Laydown Yard. Figure A-1 shows pipes buried in the sand. Figures A-2, A-4, and A-6 show missing pipe caps on pipe modules and a layer of sand built up inside. Figure A-3 shows excessive vegetation surrounding pipe modules. Figure A-5 appears to show part of an insect nest inside a structure, system, or component (SSC).

Deficient storage conditions at the MHF Laydown Yard largely result from frequent high winds, blowing sand, and tumbleweeds, combined with inadequate corrective actions. BNI project procedure, *Field Material Inventory Management*, requires monthly surveillances of the MHF Laydown Yard. BNI assigned craft personnel to correct deficiencies identified during monthly surveillances; however, these efforts were not effective in maintaining compliant storage conditions. After receiving the staff review team’s agenda, BNI temporarily removed SSCs from rows 19 and 20, removed all sand, and leveled the ground. Appendix 1, Figures A-9 and A-10 illustrate BNI’s corrective actions. BNI also submitted a request for gravel to DOE-ORP. Pending approval, BNI expects the MHF Laydown Yard will be completely resurfaced with gravel within 2 years.

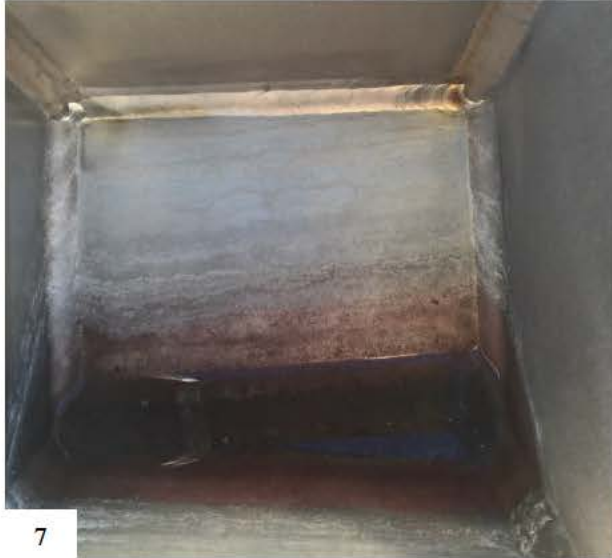
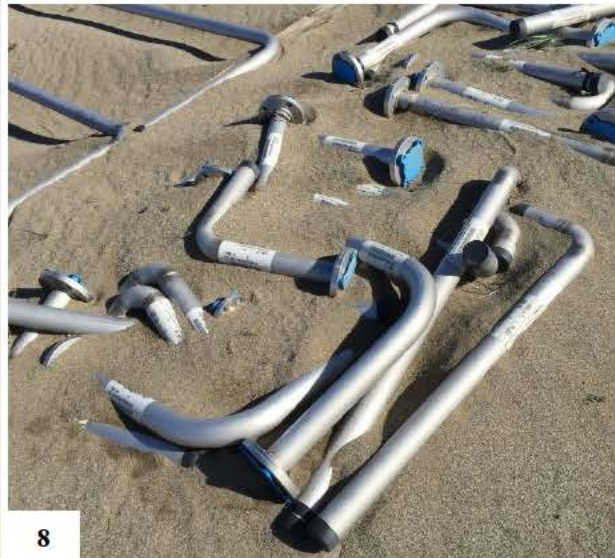
**Figures A-7 to A-8.** Staff review team photographs illustrating deficient storage conditions at the MHF Laydown Yard. Figure A-7 shows water accumulated inside a vessel. Figure A-8 shows additional pipe modules buried in the sand.

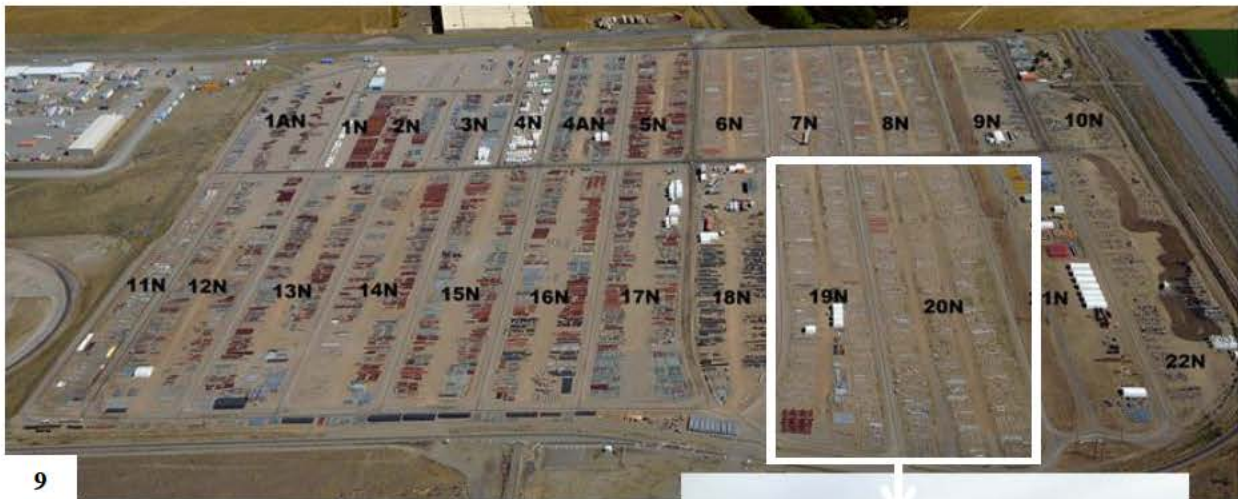
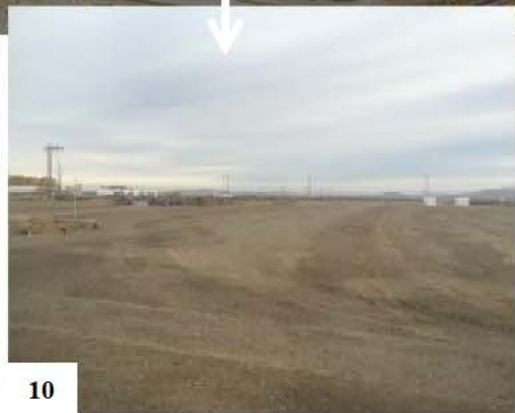
**Figures A-9 and A-10.** Photographs of the MHF Laydown Yard. Figure A-9 shows an aerial photograph of the 130 acre MHF Laydown Yard before Bechtel National, Incorporated (BNI) took corrective actions. Figure A-10 is a ground-level photograph of rows 19 and 20 following BNI corrective actions of temporarily removing all SSCs and removing the sand and leveling.

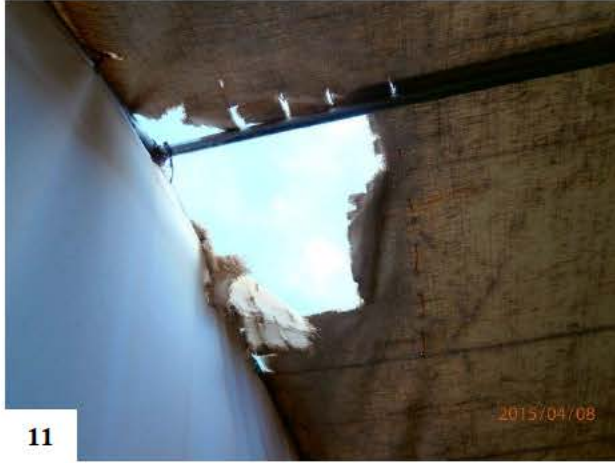
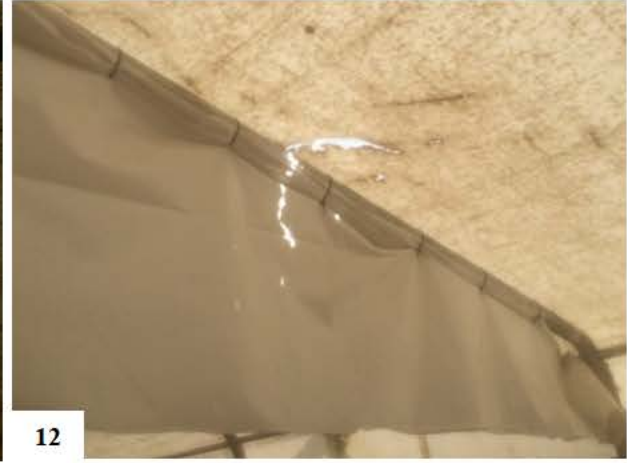
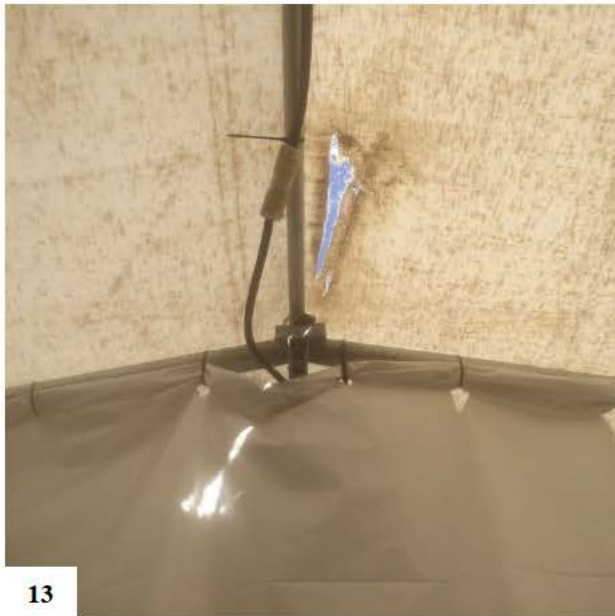
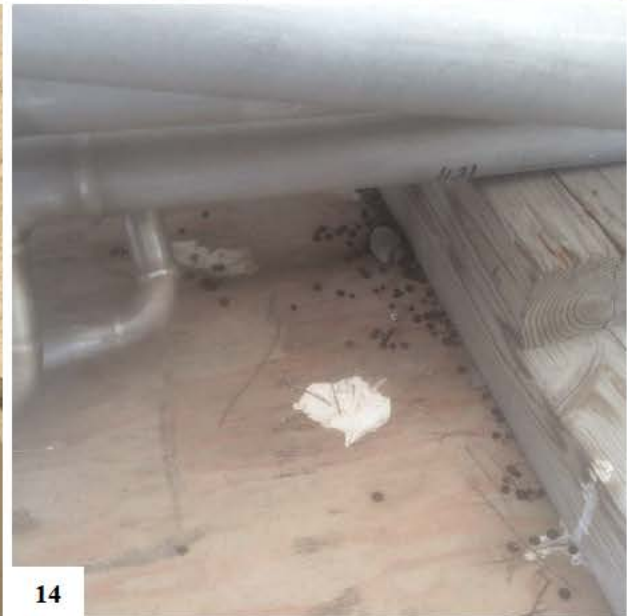
*Deficiency 2, Storage Tents*—In April 2015, , the staff photographed non-weathertight storage tents being used for “Level C Storage” at the MHF Laydown Yard and the WTP construction site. See Appendix 1, Figures A-11, A-12, and A-13, for example photographs. Some tents also showed evidence of animal intrusion. See Appendix 1, Figure A-14. These observed conditions are contrary to the following requirements:

**Figures A-11 to A-14.** Staff review team photographs illustrating deficient storage tents. Figure A-11 shows a ripped tent at the MHF Laydown Yard. Figures A-12 and A-13 show ripped tents at the Waste Treatment and Immobilization Plant (WTP) construction site. Figure A-14 shows evidence of animal intrusion in a tent at the WTP construction site.

Following receipt of the staff review team’s agenda, BNI performed an extent of condition for all Level C storage structures at the construction site. These structures included tents, small buildings, and trailers. BNI identified 10 structures requiring repairs and 8 structures that were less than adequate. BNI is relocating SSCs stored in deficient locations to warehouses. In addition, BNI will no longer designate storage tents located at the MHF Laydown Yard as Level C storage, unless they are repaired.

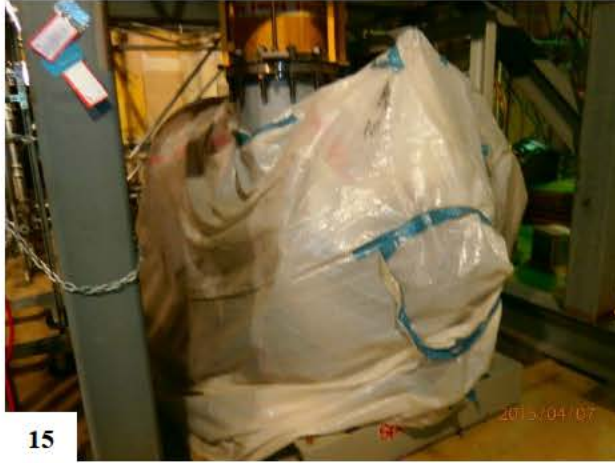
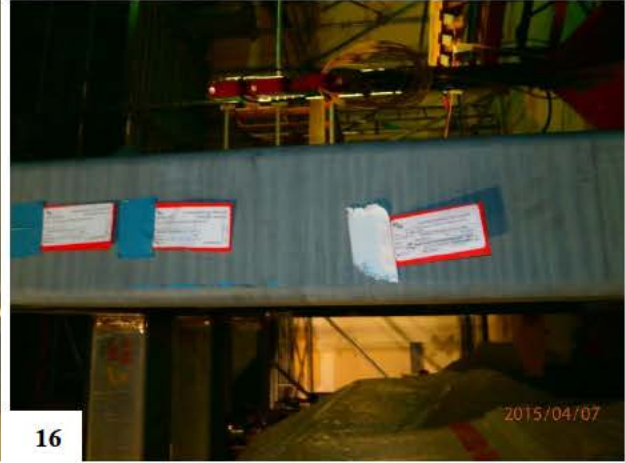
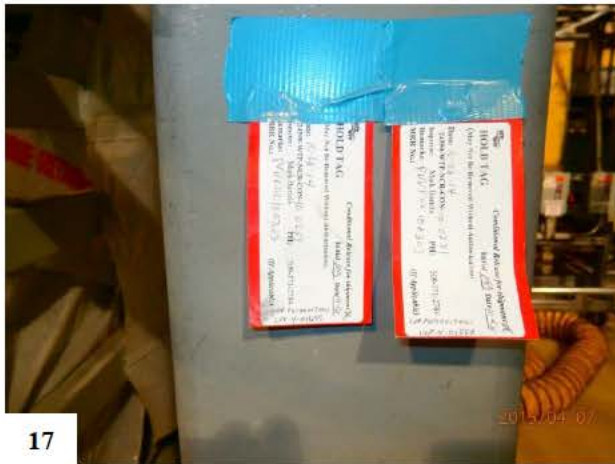
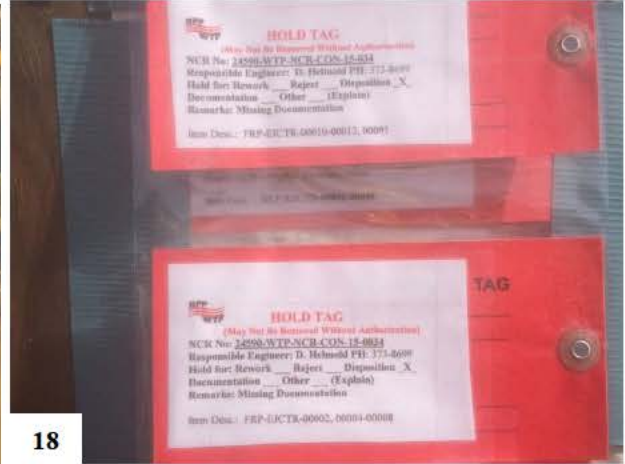
*Deficiency 5, Identification of Nonconforming SSCs*—BNI’s credited identification method for nonconforming SSCs in storage and the construction site is the use of electronic records in the Bechtel Procurement System (BPS) and Contractor Assurance Information System (CAIS) software. These electronic records identify the full list of active NCRs. In select storage areas, BNI uses electronic holds in the BPS software to identify nonconforming SSCs. When practical, BNI also hangs NCR hold tags on nonconforming SSCs. In April 2015 at the WTP construction site, the staff review team photographed NCR hold tags placed nearby when BNI judged it to be impractical to directly tag the SSC. See Appendix 1, Figures A-15 to A-18 for example photographs. These identification methods are defined in BNI project procedure, *Nonconformance Reporting and Control* [13]. This project procedure deviates from NQA-1 and the BNI project document, *Quality Assurance Manual*, without clear approval from DOE or the NQA-1 code committee. Additionally, since loss of either BPS or CAIS would result in the loss of these credited electronic records, BPS and CAIS should be evaluated against NQA-1, Requirement 17. These conditions are contrary to the requirements listed below:

**Figures A-15 to A-18.** Staff review team photographs illustrating alternate methods of identifying nonconforming items. Figures A-15 to A-17 depict Nonconformance report (NCR) hold tags on structural steel near the nonconforming item. Figure A-18 shows NCR hold tags on the outside of a storage tent near the Pretreatment Facility construction site.

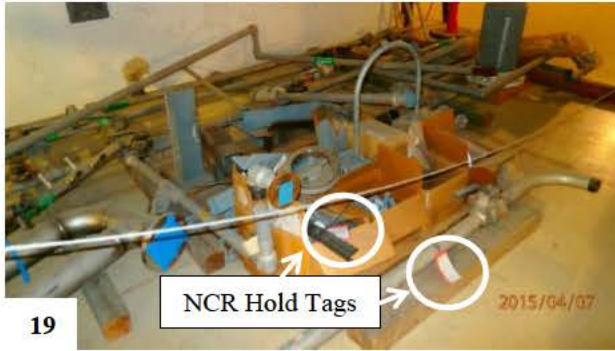
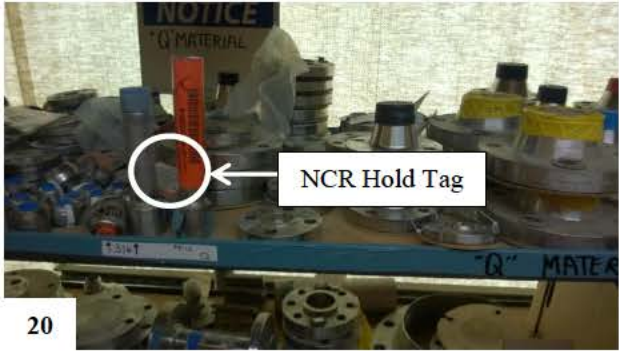
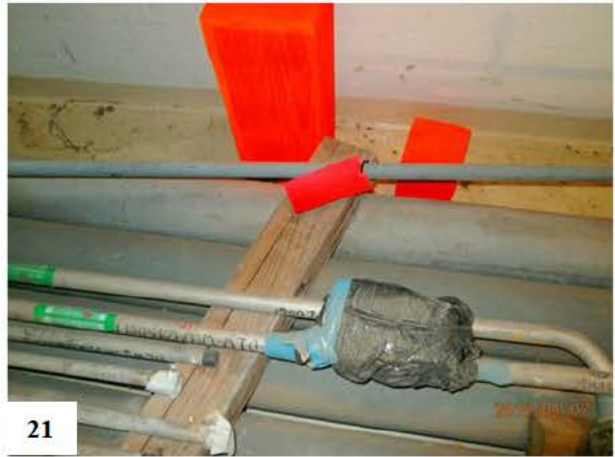
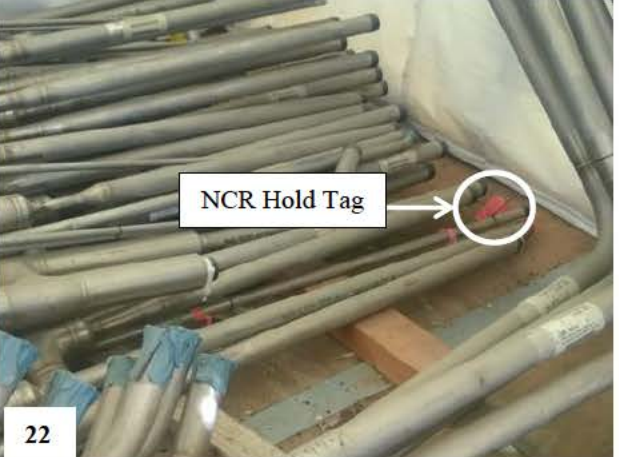
*Deficiency 6, Segregation of Nonconforming SSCs*—In April 2015 at the WTP construction site, the staff photographed some SSCs that were tagged with NCR hold tags but not segregated from other SSCs when it was practical to do so. See Appendix 1, Figures A-19 to A-22 for example photographs. These situations are contrary to NQA-1, Requirement 15, Paragraph 300, and the BNI project document, *Quality Assurance Manual*, Section 15.1.2.3.1, which require nonconforming items be segregated when practical.

**Figures A-19 to A-22.** Staff review team photographs illustrating nonconforming SSCs that were not properly segregated. Figures A-19 and A-21 are inside the High-Level Waste Facility. Figure A-20 was inside a storage area at the WTP construction site. Figure A-22 was inside a storage tent near the Pretreatment Facility.

BNI located the nonconforming SSCs and discovered that in most instances, the NCR or construction deficiency report (CDR) had been closed but the hold tag had not been removed. However, per the BNI project procedure, *Nonconformance Reporting and Control*, these SSCs should have been segregated until it was confirmed that the NCR or CDR was closed. Of note, one hold tag was for a CDR that had been closed nearly four years prior. BNI personnel said that they have now segregated the nonconforming SSCs identified by the staff review team. In addition, they said that they removed the closed NCR and CDR hold tags from the SSCs. BNI did not disagree with this issue, but it has not discussed other corrective actions besides segregating the items and removing the tags identified by the staff review team.

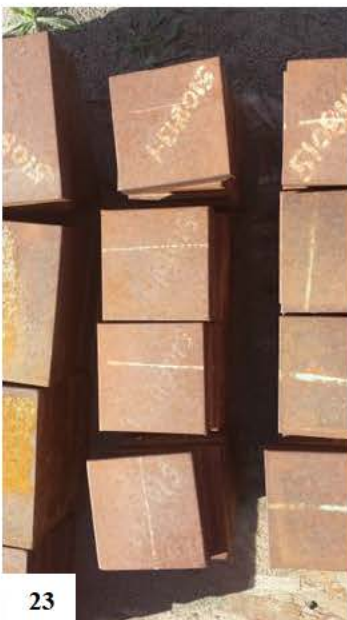
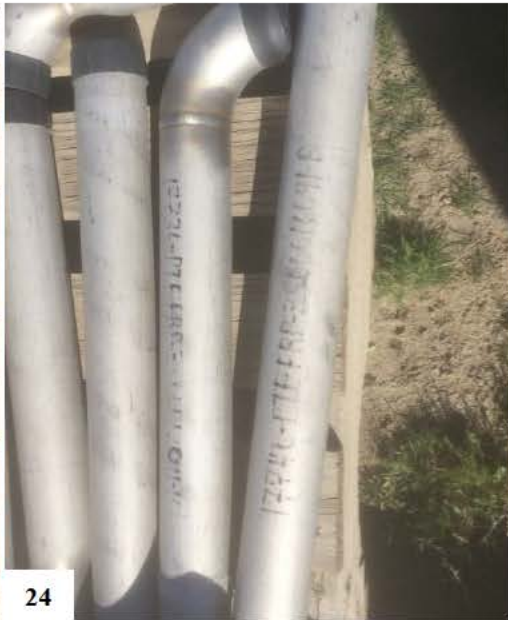
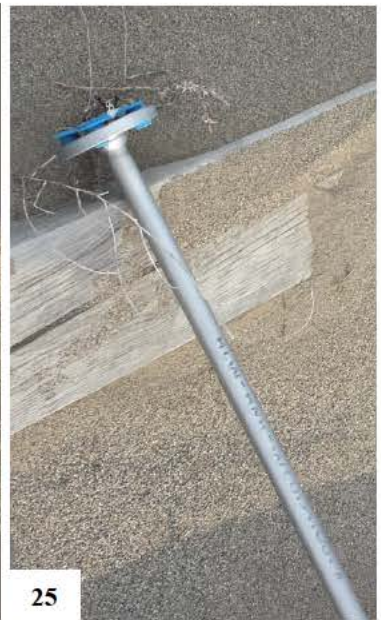
*Deficiency 8, SSC Identification Markings*—In April 2015, the staff review team photographed several SSCs in the MHF Laydown Yard with illegible identification markings. See Appendix 1, Figures A-23 to A-25 for example photographs. This condition is contrary to NQA-1, Requirement 8, and the BNI project document, *Quality Assurance Manual*, Section 8.1.2.3, which require legible identification. In April 2015, the staff review team conducted a sample inventory audit of SSCs at the MHF Laydown Yard. The staff review team experienced difficulty reading the correct labeling on several pipe spools with faded hand-written labeling. However, BNI and the staff review team were eventually able to use the BPS software and photographs to correctly interpret the labeling on each pipe spool. BNI is in the process of replacing hand-written identification labels with a more durable barcode labeling system.

**Figures A-23 to A-25.** Staff review team photographs illustrating illegible physical markings of SSCs at the MHF Laydown Yard.

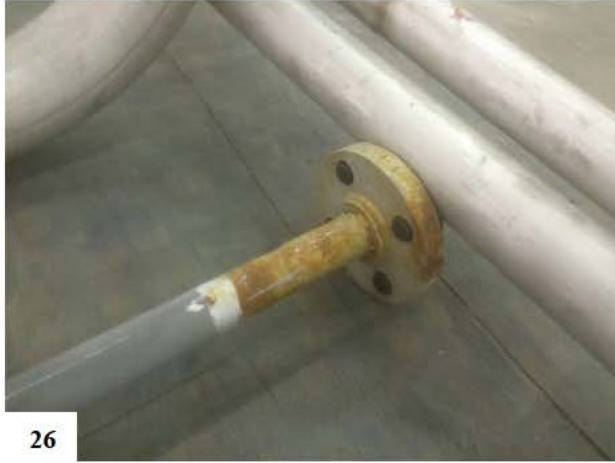
26

*Deficiency 9, Segregation of Dissimilar Metals*—In April 2015, the staff review team photographed carbon and stainless steel piping in contact at the Yakima Warehouse and High-Level Waste Facility. The staff also photographed a carbon steel flange cover used on a stainless steel vessel in the 4.5-Acre Laydown Yard. See Appendix 1, Figures A-26 to A-29, for example photographs. Carbon and stainless steel piping in contact is contrary to a BNI engineering specification, *Field Fabrication and Installation of Piping* [14], Section 3.1.5.1 and the BNI project procedure, *RPP/WTP Storage Plan*, Section 3.1. An additional BNI engineering specification, *Packaging, Handling, and Storage Requirements* [15], Section 5.7.1, prohibits carbon steel flange covers on stainless steel vessels by stating, “Metallic plugs and caps contacting metal surfaces shall not cause galvanic corrosion at the contact areas.” DOE Order

**Figures A-26 to A-29.** Staff review team photographs illustrating improper segregation of dissimilar metals. Figures A-26 and A-27 show carbon and stainless steel in contact at the Yakima Warehouse. Figure A-28 shows carbon and stainless steel in contact at the High-Level Waste Facility. Figure A-29 shows a carbon steel flange cover on a stainless steel vessel at the WTP construction site

Following receipt of the staff review team's agenda on June 29, 2015, BNI conducted an extent of condition review. BNI personnel said they had corrected all instances of carbon and stainless steel piping in contact. They also said they had identified several other instances where carbon steel flange covers were being used on stainless steel equipment, which were also corrected.
