Subject: Comments Relating to “Safety During Recovery and Resumption of Operations; DNFSB Waste Isolation Pilot Plant Public Hearing, Carlsbad, New Mexico Wednesday April 29, 2015”.

Enclosure as Stated: Nuclear Safety, Volume 33, No. 2, April-June 1992: “An Assessment of the Flammability and Explosion Potential of Defense Transuranic Waste” by Dr. Matthew Silva

WASTE DRUM EXPLOSION AT ARGONNE NATIONAL LABORATORY

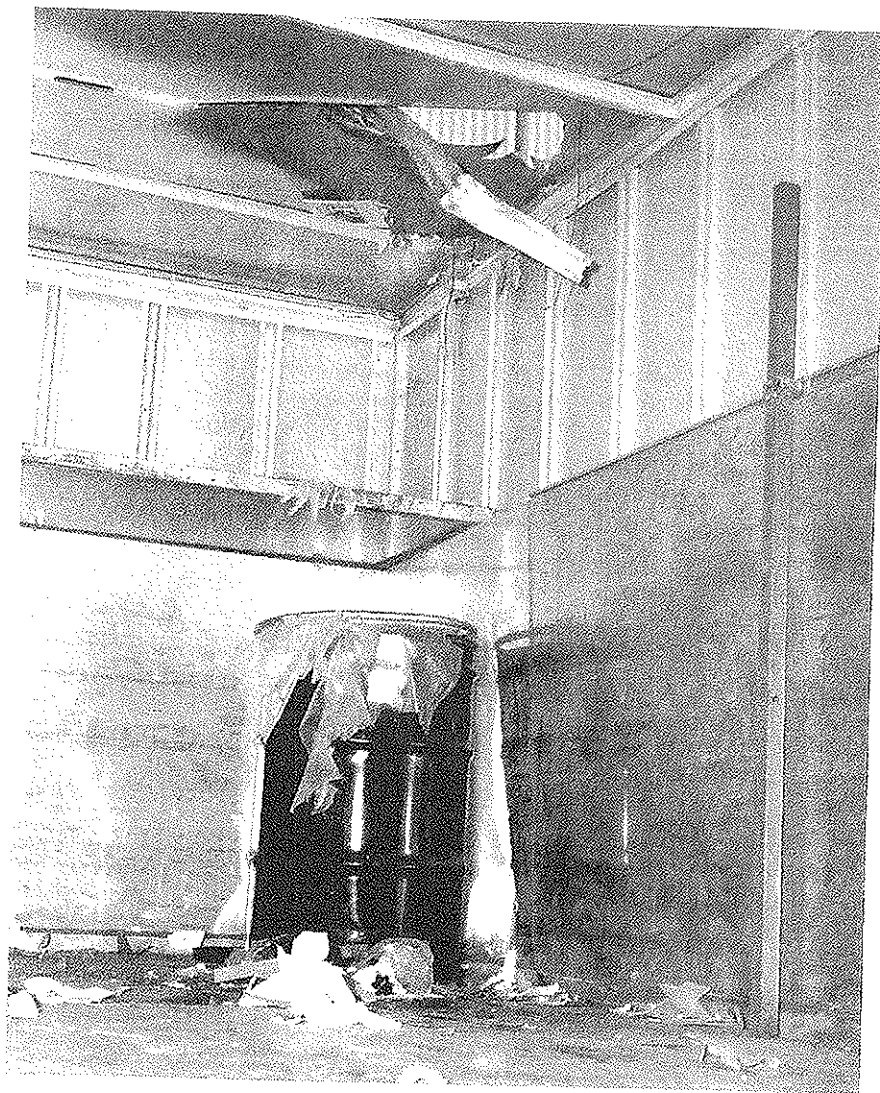
The explosion had blasted the lid of the drum through the aluminum roof of the van either during the late hours of December 2 or the early hours of December 3. The drum showed considerable bottom deformation. That observation, coupled with an analysis of the deformed aluminum spherometer cans within the unbreached polyvinyl chloride (PVC) pouches, "characterized the incident as an explosion rather than a gradual overpressurization. . . ."⁸

Fig. 1 Damage inside a truck at Argonne National Laboratory-East caused by the explosion of a 55-gal drum containing mixed radioactive waste. Published with permission of authors and the U.S. Department of Energy.

Figure 1^a clearly shows the gaping hole in the metal roof of the van and the mangled reinforcing beam that had been part of the roof structure. Eight 55-gal drums and many fiber cartons of waste were in the truck at the time of the explosion. The explosion apparently occurred in the void space of one of the 55-gal drums and not within one of the bags. The drum lid was found on top of the truck.

One PVC pouch contained two flammable organic solvents, xylene and pentane, that had been absorbed on a widely used material referred to as "Oil Dri." Apparently the solvents diffused through the PVC pouch and accumulated in the drum void space.⁸

Mueller et al.⁸ concluded that an electrical discharge within the sealed drum probably initiated the explosion. They cautioned that their assumption of an electrical discharge did not preclude other mechanisms, such as spontaneous heating, chemical reactions, or radiation effects.

As noted by Mueller et al.,⁸ compliance with existing procedures would have prevented this accident. Site practices at ANL-E in 1976 included evaporation of liquids before disposal of containers. In this incident, the evaporation practice was apparently initiated and then abandoned because the material was evaporating too
