**Final Report**

**February 2000**

**Type B Accident Investigation Board  
Report of the  
September 1, 1999, Plutonium Intakes  
at the  
Savannah River Site FB-Line**

Type B Accident  
Investigation Report of  
the September 1, 1999,  
Plutonium Intakes at the  
Savannah River Site  
FB-Line

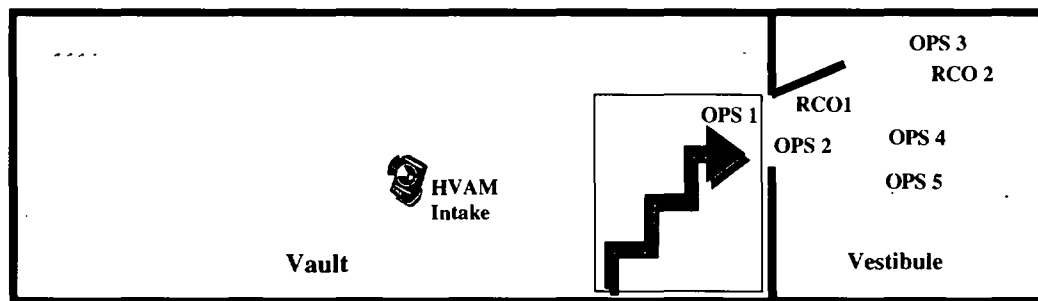
**Figure 2-1** Diagram of Vault/Vestibule Area

At 0942 hours on September 1, 1999, eight personnel entered the FB-Line vault stairway to perform two tasks: batching and transporting characterization samples per Standard Operating Procedure (SOP) 221-FB-1781-NS, and packaging bagless cans containing plutonium-bearing materials into shipping containers per SOP 221-FB-1186-H-NS. The workers included six FB-Line operations personnel and two RCO inspectors. (To trace and identify activities in this report, these individuals are designated as OPS 1, OPS 2, OPS 3, OPS 4, OPS 5, OPS 6, RCO 1, and RCO 2.) At 0944 hours, OPS 6 remained stationed in the vault stairway and the remaining seven personnel entered the vault/vestibule area (*Figure 2-1*).

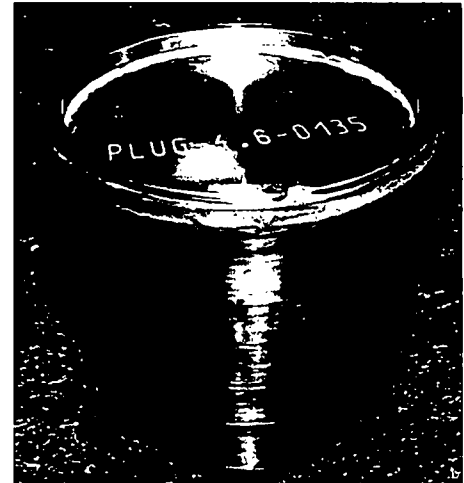
**Figure 2-2** Representative Bagless Can

- The bagless canister design consists of an American Iron and Steel Institute Type 304L stainless steel cylindrical canister (*Figure 2-2*). The process calls for the canister to be back-filled with helium, automatically seal-welded to an internal hollow plug using a single-pass, fillerless Gas Tungsten Arc/Tungsten Inert Gas weld, and cut into two parts, with one part remaining as the glove box seal and the other part (containing plutonium) placed into storage.
