Integrity of Uranium Hexafluoride Cylinders

Defense Nuclear Facilities Safety Board

Technical Report

May 5, 1995

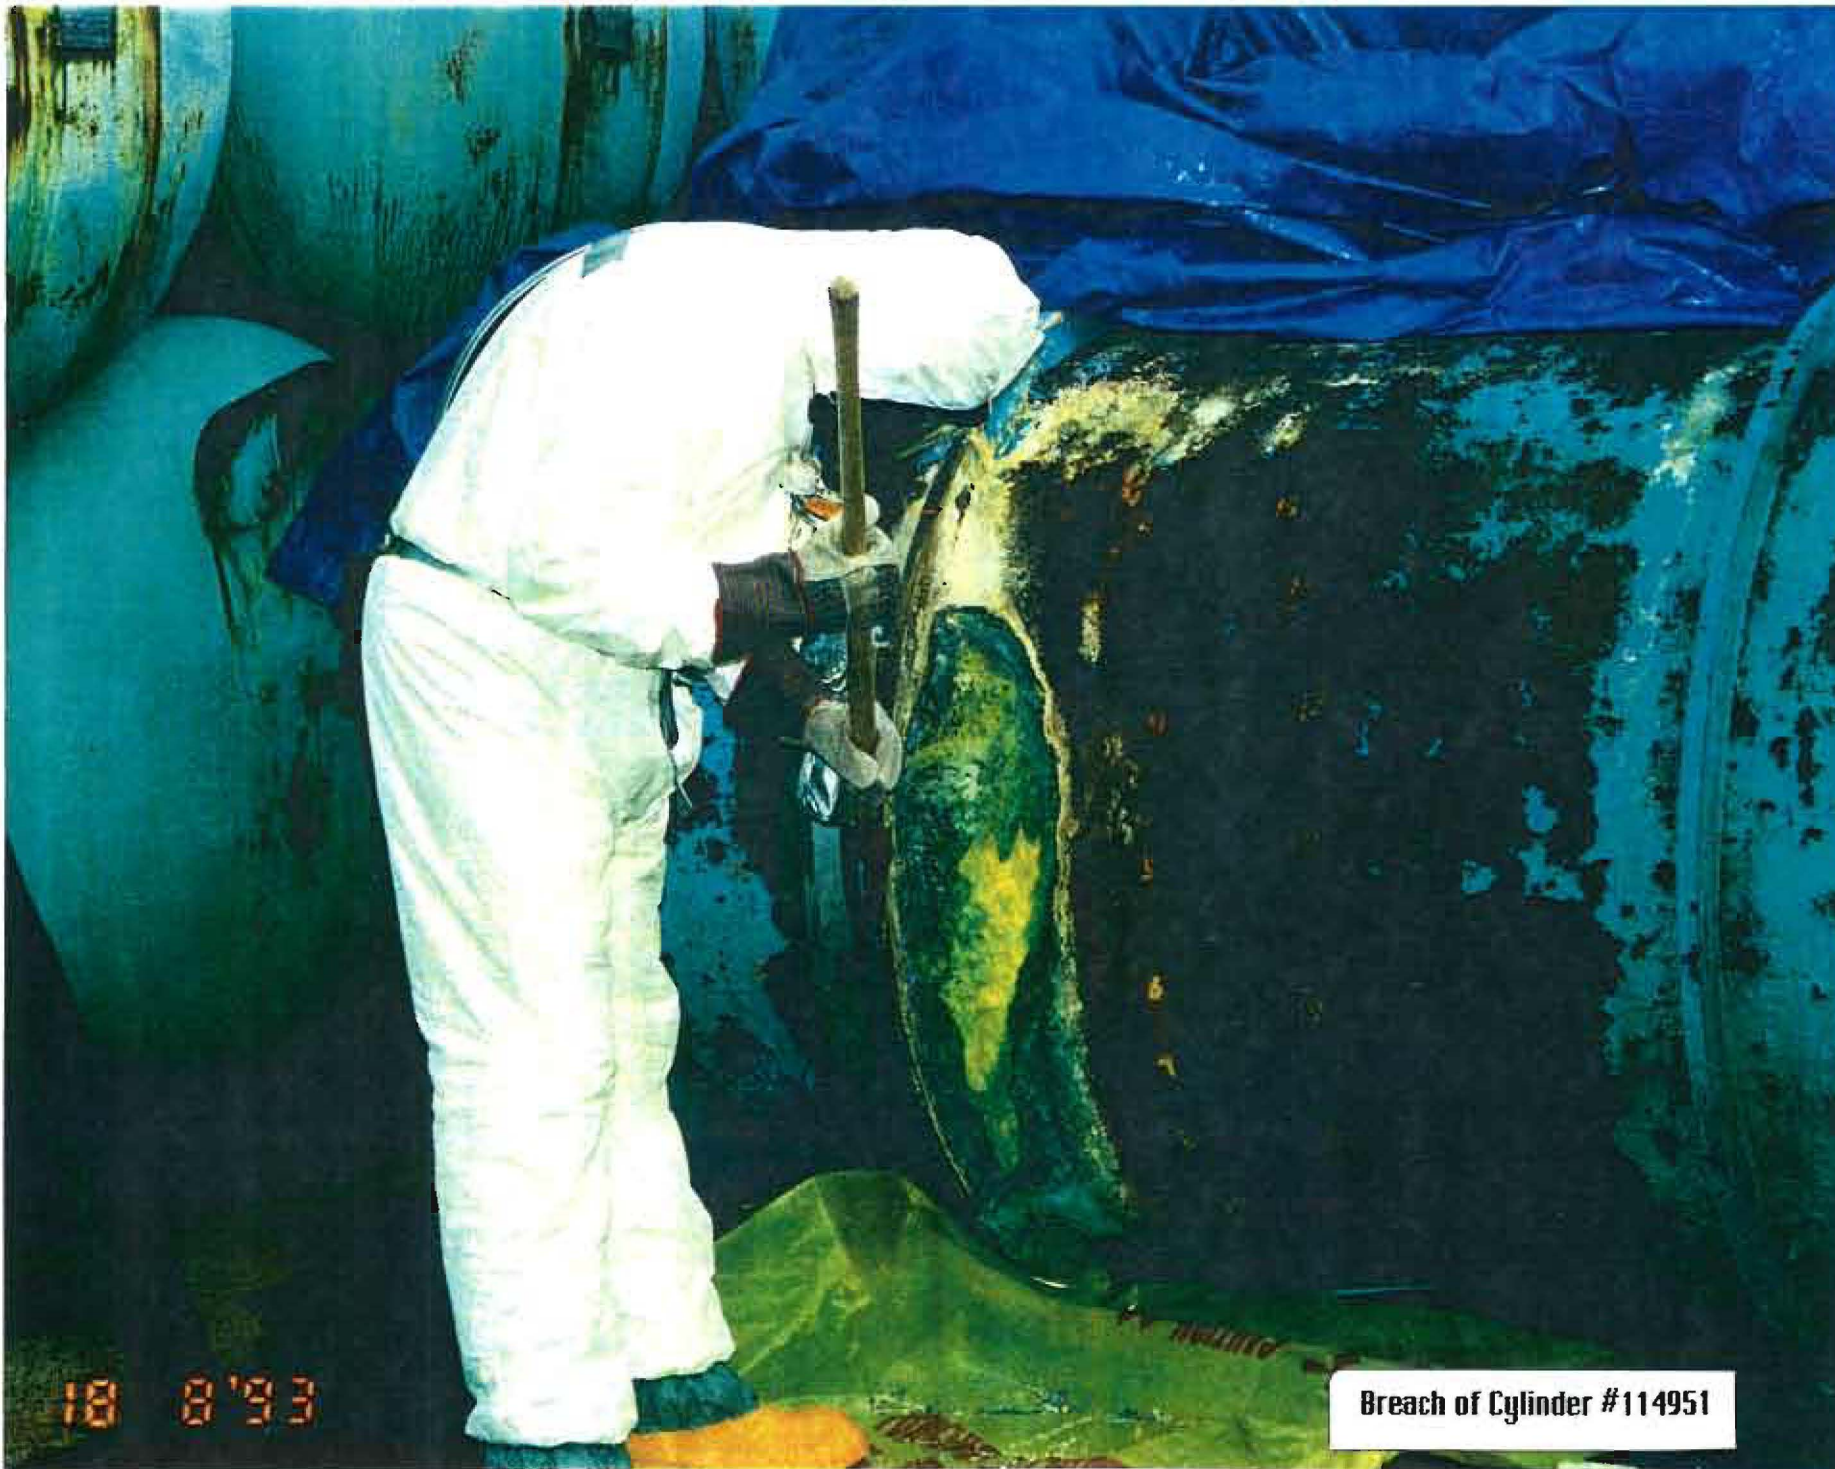
When released to the atmosphere, gaseous UF_6 reacts with water vapor to form a cloud of particulate UO_2F_2 and HF fumes. The reaction is fast, but is dependent on the availability of water. External contact with HF results in chemical burns of the skin, while exposure to airborne HF causes chemical burns/irritation of the eyes, nose, and throat. Because UF_6 reacts readily with water and organic materials, it must be handled in clean equipment and out of contact with moist air. A breach in a cylinder allows the external atmosphere to react slowly with the UF_6 . The solid reaction product tends to plug the breach; however, the HF formed releases slowly, attacks the metal cylinder, and enlarges the breach over time. The hole diameter is estimated to increase at a rate of approximately one inch per year. The reaction products, consisting of UF_4 , FeF_3 , and other iron oxides, fall to the ground or onto adjacent cylinders. The material released to the environment is HF and solvated uranyl fluoride $[H_3O]_2[U(OH)_4F_4]$, which is soluble in water. Figure 2. is a photograph of the largest breach discovered to-date.

Figure 2 Breached Cylinder at Oak Ridge K-25 Site

The most probable cause of five of the seven breaches discovered is the lifting lug or stiffening ring of an adjacent cylinder impinging upon the breached cylinder. During testing at Paducah, it was determined that an impact adjacent to a welded stiffening ring may result in tearing of the cylinder wall (*Fracture Control of Steel UF₆ Cylinder*¹⁰). While only five cylinder breaches have been attributed to this mechanism, a large number of cylinders at all three facilities have such damage. Although modified handling procedures direct that the lugs be oriented to avoid impinging on adjacent cylinders, there will still be impact between the stiffening rings of one cylinder and the wall of another when an upper row cylinder is dropped into place. This situation has not been sufficiently examined as a potential cause of tearing of the cylinder wall, especially in older, deteriorated cylinders.

Remediation of the four breached cylinders at K-25 is apparently being handled as a low priority task. Although the breached cylinders were discovered in late 1991 and early 1992, they still await shipment to Portsmouth or Paducah, where capability exists to off-load the contents. The *UF₆ Long-Term Cylinder Integrity Management Plan* originally scheduled obtaining Department of Transportation approval to transport one of the cylinders from K-25 by September of 1993, but the approval request has yet to be submitted by DOE. K-25 is therefore still, after four years, "maintaining" the hazards associated with storage of four incompletely patched cylinders.
