DEFENSE NUCLEAR FACILITIES SAFETY BOARD

September 4, 1996

MEMORANDUM FOR:	G. W. Cunningham, Technical Director	
COPIES:	Board Members	
FROM:	Derek N. Barboza	
SUBJECT:	On-Site Review of Electrical Systems at the Rocky Flats Environmental Technology Site

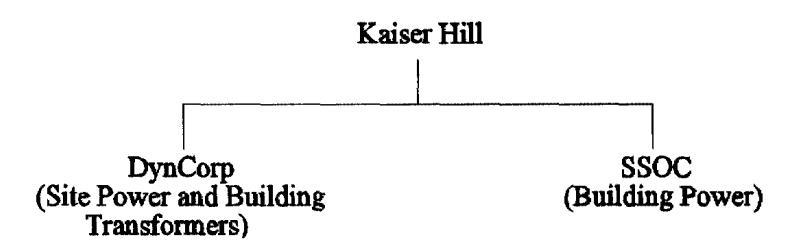
Figure 1. Integrating Contractor Responsibilities for Electrical Systems

DOE utilizes Kaiser-Hill, the integrating contractor, to maintain and operate the facilities at Rocky Flats. Kaiser-Hill uses various subcontractors to maintain and operate the site. Figure 1 shows the responsibilities of the subcontractors with respect to electrical systems. DynCorp is responsible for operating and maintaining systems to provide power up to the facilities. Safe Sites of Colorado (SSOC) operates and maintains the buildings, including operating and maintaining normal electric and emergency power.
