**Final Report**

**February 2000**

**Type B Accident Investigation Board  
Report of the  
September 1, 1999, Plutonium Intakes  
at the  
Savannah River Site FB-Line**

Type B Accident  
Investigation Report of  
the September 1, 1999,  
Plutonium Intakes at the  
Savannah River Site  
FB-Line

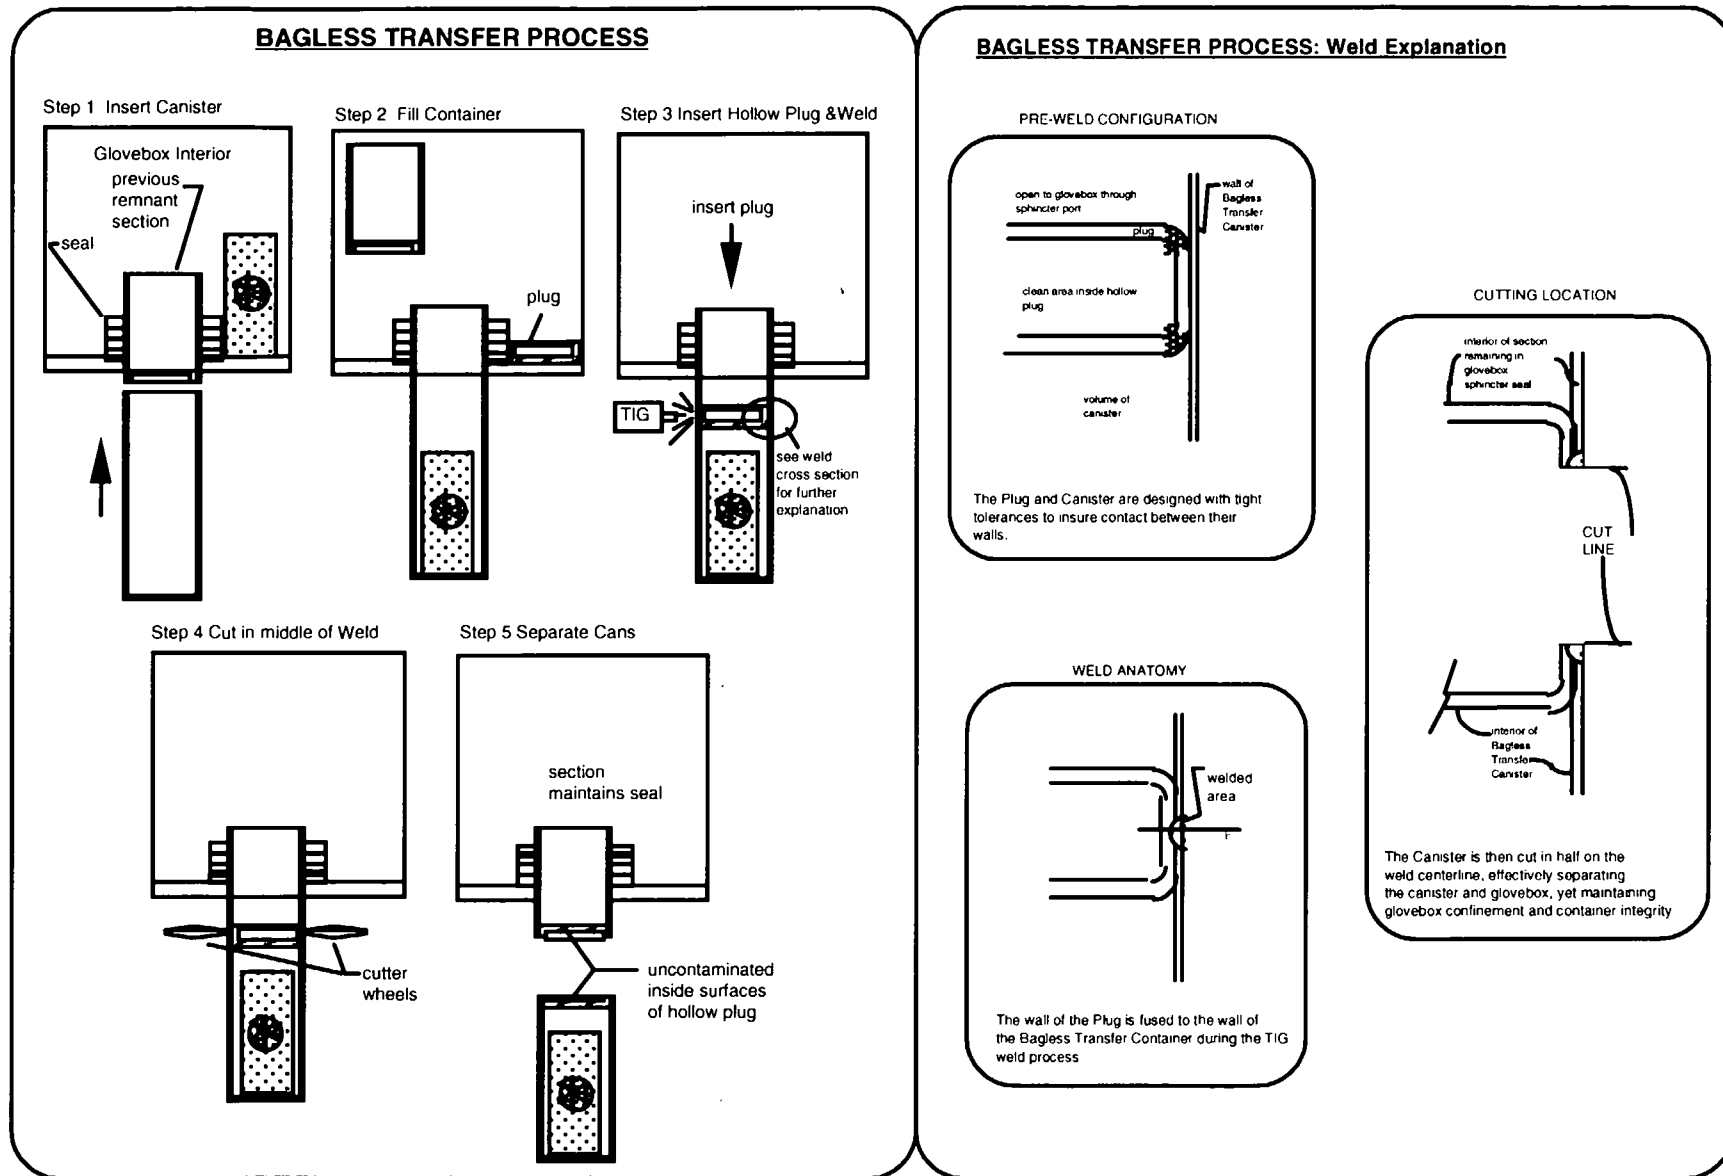
Figure 1-3 Bagless Transfer System Overview

The goal of the bagless transfer system is to remove plutonium metal from a glovebox and seal it in a welded stainless steel can without contaminating the outside of the can. The bagless transfer process takes place in five steps (*Figure 1-3*). The first step is to insert a new canister into the bottom of the glovebox, displacing the remaining portion of the previous canister from the sphincter seal. The seal allows movement of the round canister into the glovebox while preventing leakage of plutonium contamination from the glovebox. The second step is to place

the plutonium into the canister while minimizing contamination of the canister wall, and backfill the canister with helium. The third step is to insert a close-fitting, hollow plug into the container and fuse the outer container to the inner plug via a single-pass, fillerless Gas Tungsten Arc Weld/Tungsten Inert Gas (TIG) welding process. The TIG welder produces three tack welds, about 90 degrees apart, and then begins a continuous overpass weld that completely encircles the can and tapers off after overlapping the start location by a small amount. The fourth step is to cut the container in the approximate center of the weld using a roller-wheel-type pipe cutter. The final step involves leaving the upper portion of the canister in the sphincter seal to maintain glovebox integrity, with the bottom portion becoming a leak-tight, all-metal, welded container.

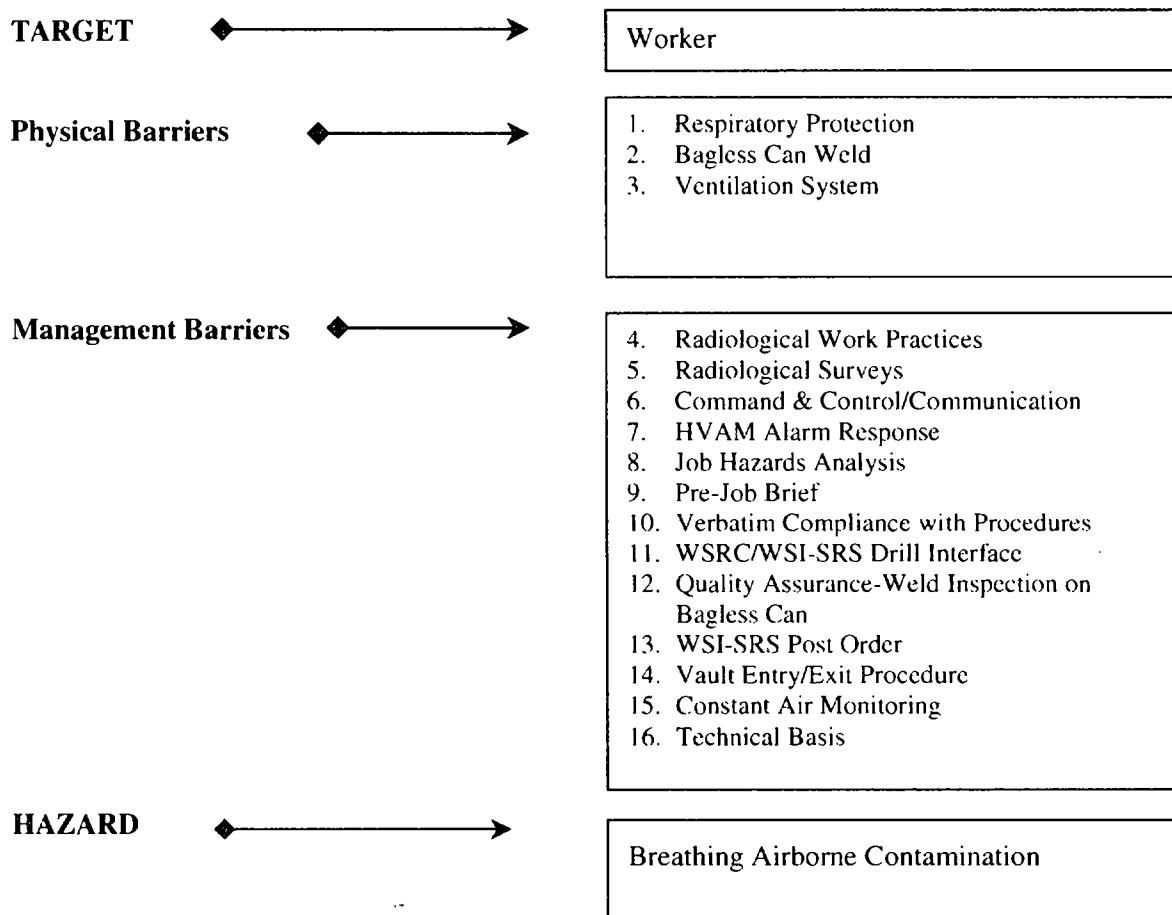
Table 2-4. Consolidated Barrier Analysis and ISMS Link

Barrier analysis is based on the premise that hazards are associated with all accidents. A barrier is any means used to control, prevent, or impede the hazard from reaching the target (persons or objects that a hazard may damage, injure, or harm). Table 2-4 presents the Board's summary of physical and management barriers, consolidated from Table 2-5. Table 2-5 documents the complete barrier analysis performed by the Board.

The identified physical and administrative/managerial barriers link to the five core **Integrated Safety Management System functions** as follows:

- Define Work Scope: 3, 9, 13, 14.
- Analyze Hazards: 5, 8, 7, 16.
- Implement Hazard Controls: 1, 2, 3, 5.
- Perform work Within Controls: 3, 4, 5, 6, 7, 10, 15.
- Provide Feedback for Improvement: 11, 12.

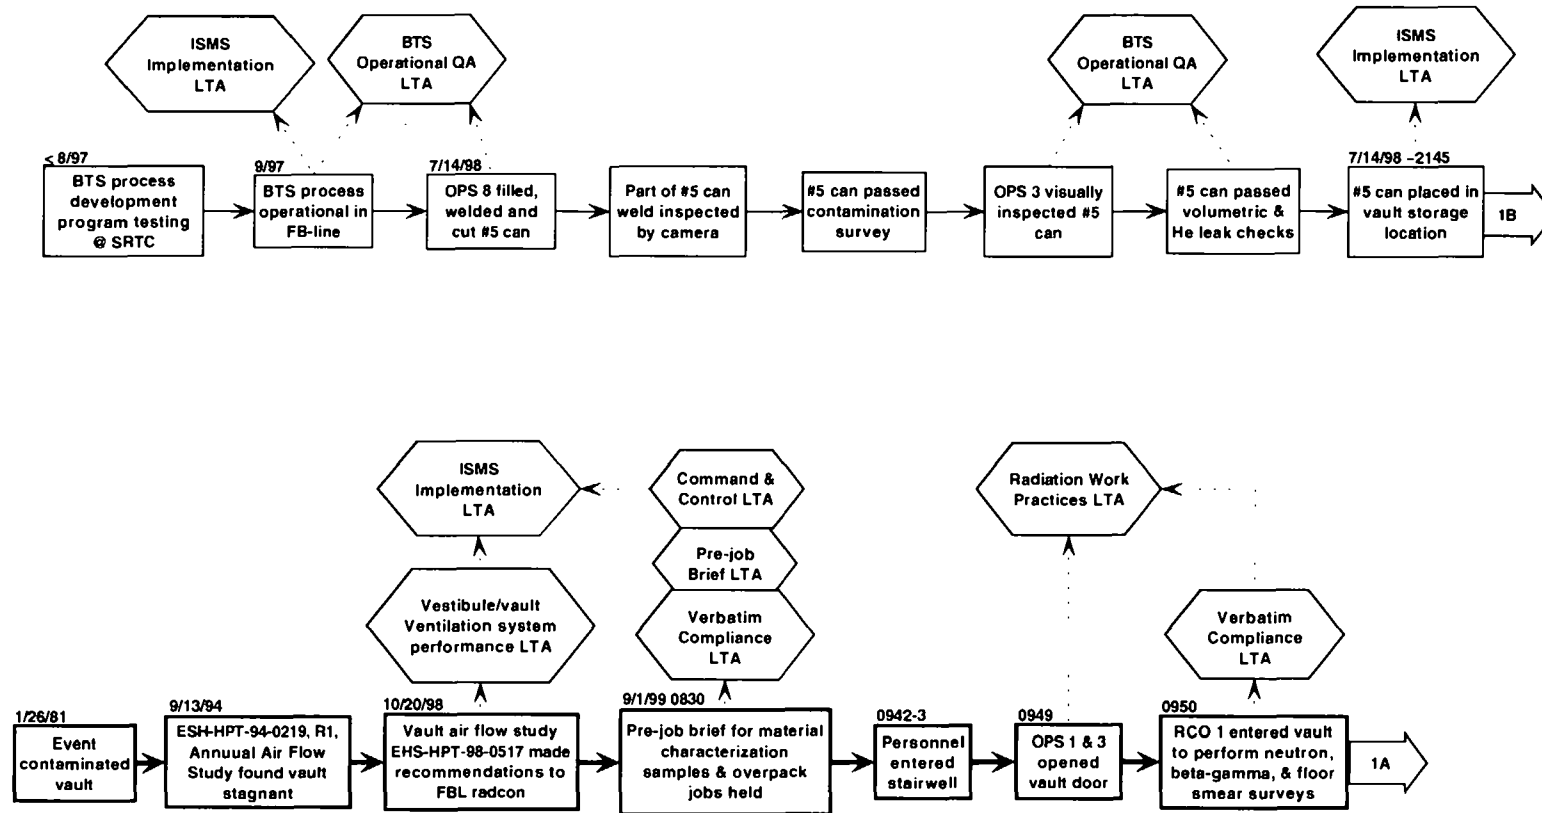
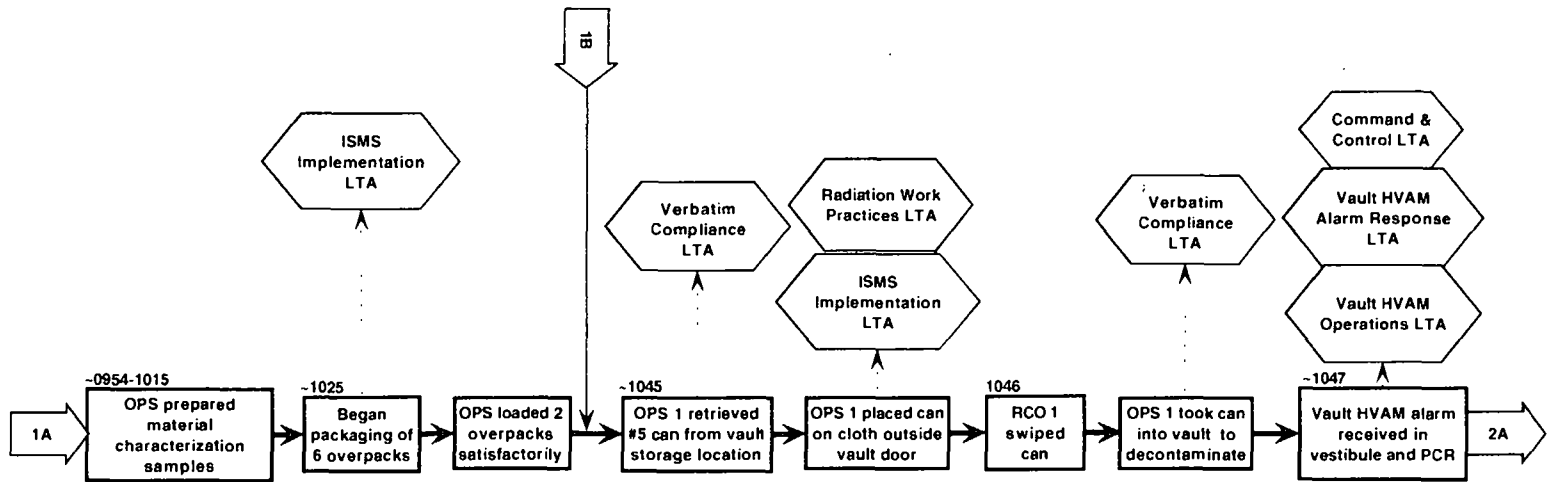
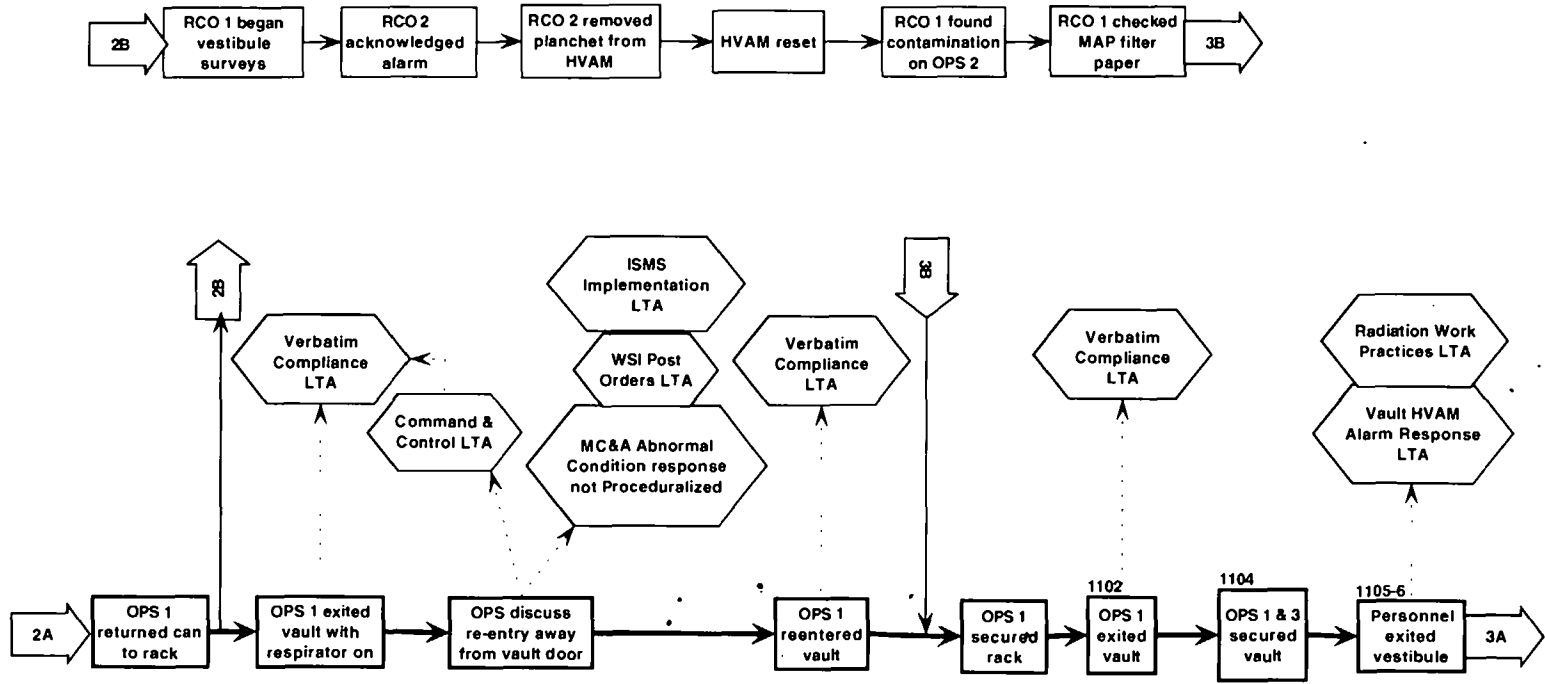
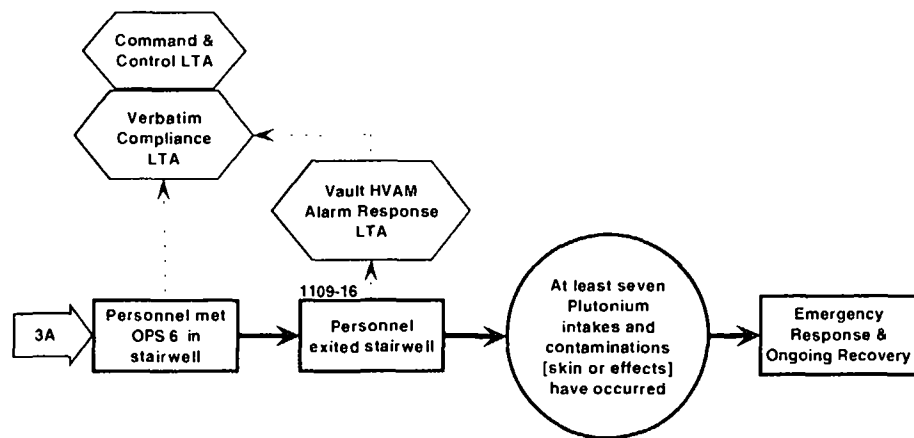
SUMMARY EVENTS & CAUSAL FACTORS CHART FOR  
PLUTONIUM INTAKES AT FB-LINE SEPTEMBER 1, 1999

Causal factors are the events and conditions that produced or contributed to the accident. The direct cause is defined as the immediate event or condition causing the accident. The Board determined the direct cause of the accident was the release of plutonium from a defective bagless transfer can, resulting in inhalation of plutonium by FB-Line workers.

- Quality assurance on the bagless transfer system canister was not adequate to identify the weld defect.
- Implementation of integrated safety management for plutonium vault operations was inadequate to provide worker protection during interim plutonium storage and handling.
