Integrity of Uranium Hexafluoride Cylinders

Defense Nuclear Facilities Safety Board

Technical Report

May 5, 1995

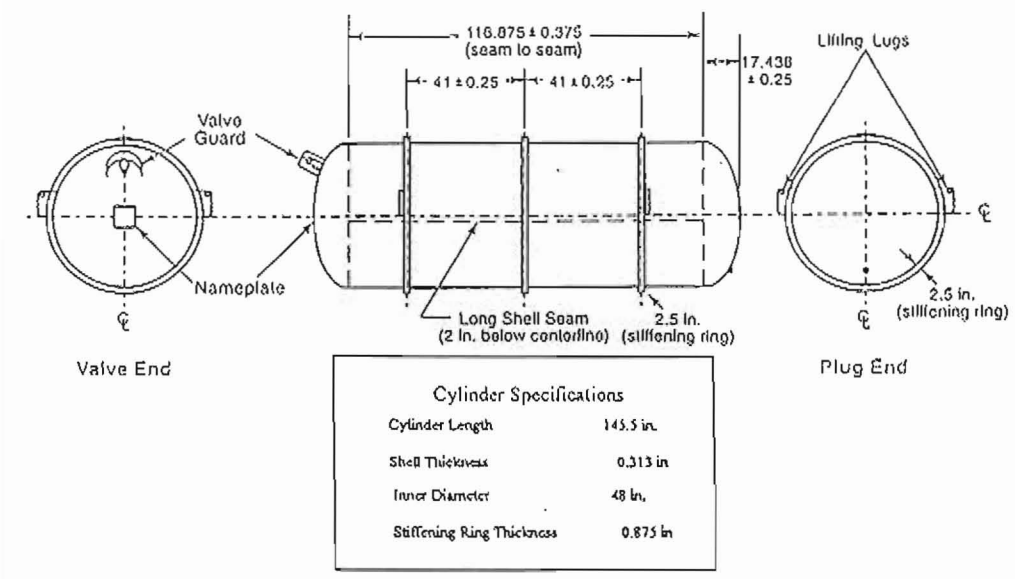
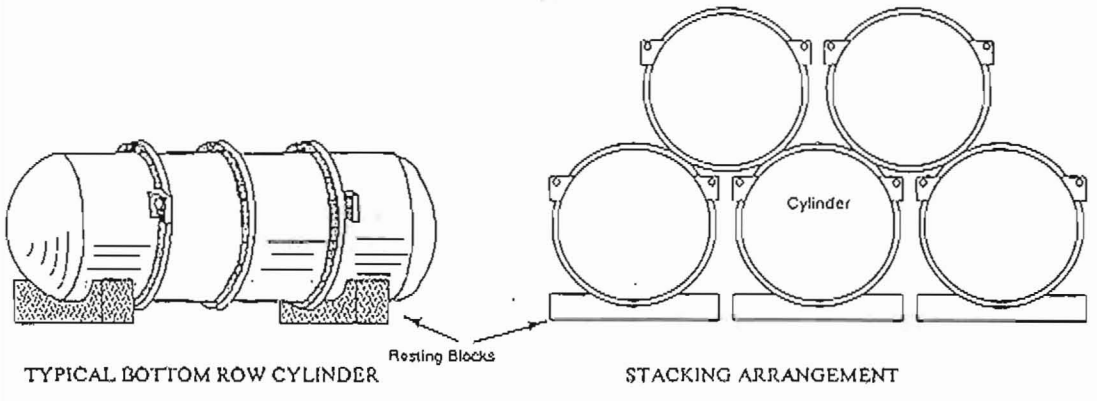
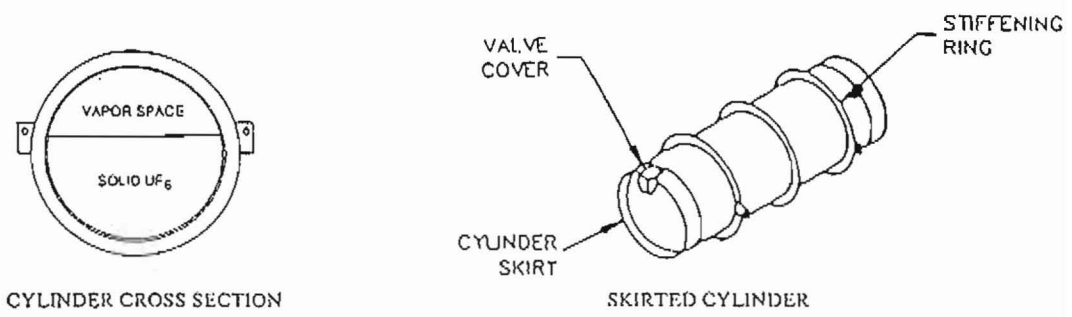
Various Cylinder Views
Figure 3

It does not appear that inspection methods, such as ultrasonic thickness measurements, are consistently being used in a manner that will provide needed information about the extent and rate of cylinder corrosion. For example, thickness measurements made on cylinders at K-25 were not correlated with the actual storage history of the cylinders (e.g., ground contact versus non-ground contact, or surfaces formerly on resting blocks). Also, ultrasonic measurements of the cylinders at K-25 and the bottom row of cylinders at Paducah were typically limited to spots that visually appeared to be the most corroded. Views and stacking arrangements of typical cylinders are shown in Figure 3.
